# Manhole Inspection Summary

Manhole # S55E\_\_036MH

Insp Date: **7/22/08 1:59 PM**

**Location** Address: **201s eaton st**

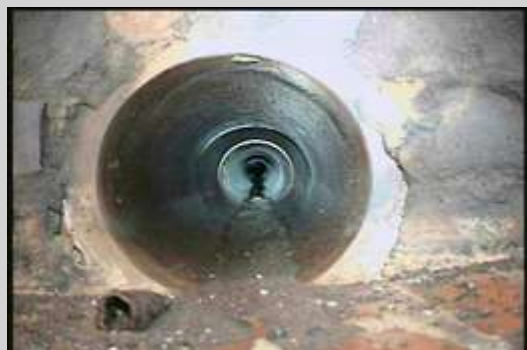
12 O'Clock Outflow

8 in. Circular Gravity Sewer  
Pipe Out @ 12 O'Clock

Infiltration: **None** Pipe Seal Cond: **Unknown**
